An Evaluation of Roadside Activity and Behavior of Deer and Black Bear to Determine Mitigation Strategies for Animal-Vehicle Collisions

Final Report VTRC 16-R4

October 2015
VTRC 16-R4

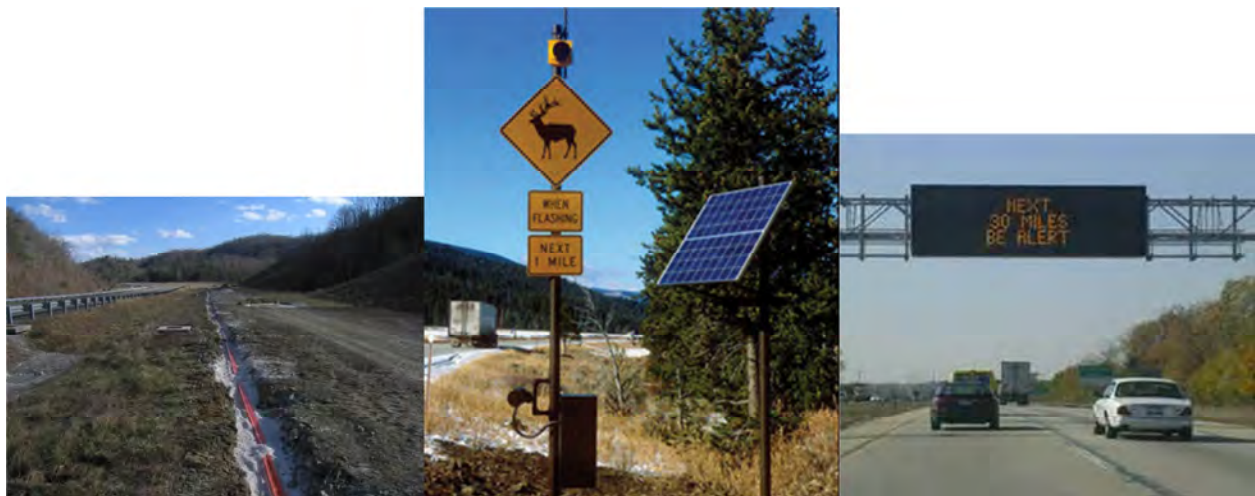
Figure 1. Driver Warning Systems. Buried cable animal detection system during installation (*left*); flashing warning system that can be connected to a detection system (*center*); dynamic message sign (*right*).

Most animal detection systems contain either above-ground area-cover sensors or break-the-beam sensors (Figure 1). In their recently completed study of a buried cable animal detection system installed along a test road (closed to public traffic), Druta and Alden (2015) found that with proper installation and calibration, the system detected large animals with more than 95% reliability, even when the cable was covered with up to 3 feet of snow (a factor that can block the sensors of other detection systems). Buried cable detection systems offer numerous apparent advantages over above-ground detection technologies when environmental variables such as precipitation and vegetation and site-specific characteristics such as topology, subsidence, and road curvature are considered (Huijser et al., 2006b). However, additional research is needed to determine the system's effectiveness at reducing DVCs on a Virginia road.

Dynamic, or "changeable," message signs are another option used to reduce DVCs, particularly if applied only seasonally to reduce driver habituation effects (Figure 1).

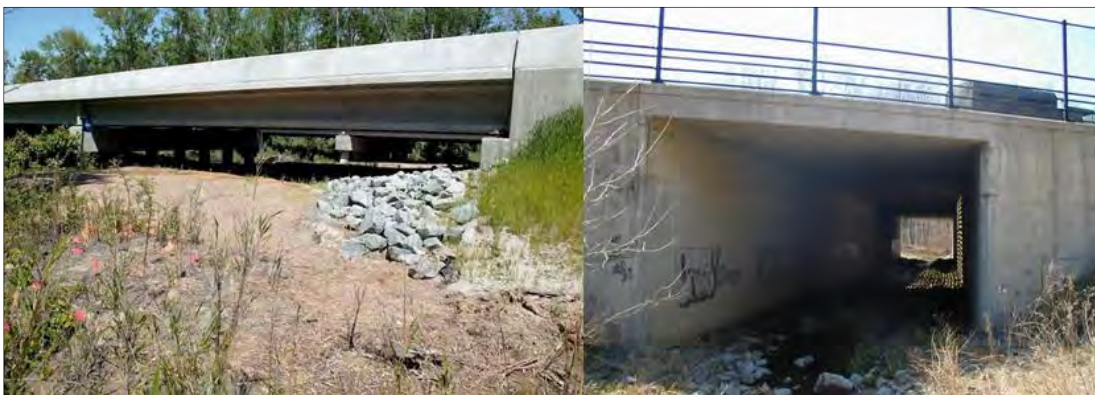
Figure 2. Bridge Underpass Beneath U.S. Highway 17 (left); Large Box Culvert Beneath Fairfax County Parkway (right). Both are used frequently by deer and other wildlife (Donaldson, 2007; Donaldson and Schaus, 2009).

Similar to many roads in the United States, I-64 includes several bridge and culvert underpasses that are large enough to facilitate passage of large animals. Because these structures were constructed for drainage or other purposes unrelated to wildlife passage, they are typically spaced miles apart and have no fencing. Although Virginia has very few underpass structures that were specifically designed for large animals, deer using box culverts with openings as small as 6 by 10 feet have been documented (Donaldson, 2007). Larger underpasses, such as large culverts or bridges spanning rivers or wetlands, receive substantially more use by deer and other wildlife (Donaldson, 2007; Donaldson and Schaus, 2009) (Figure 2).

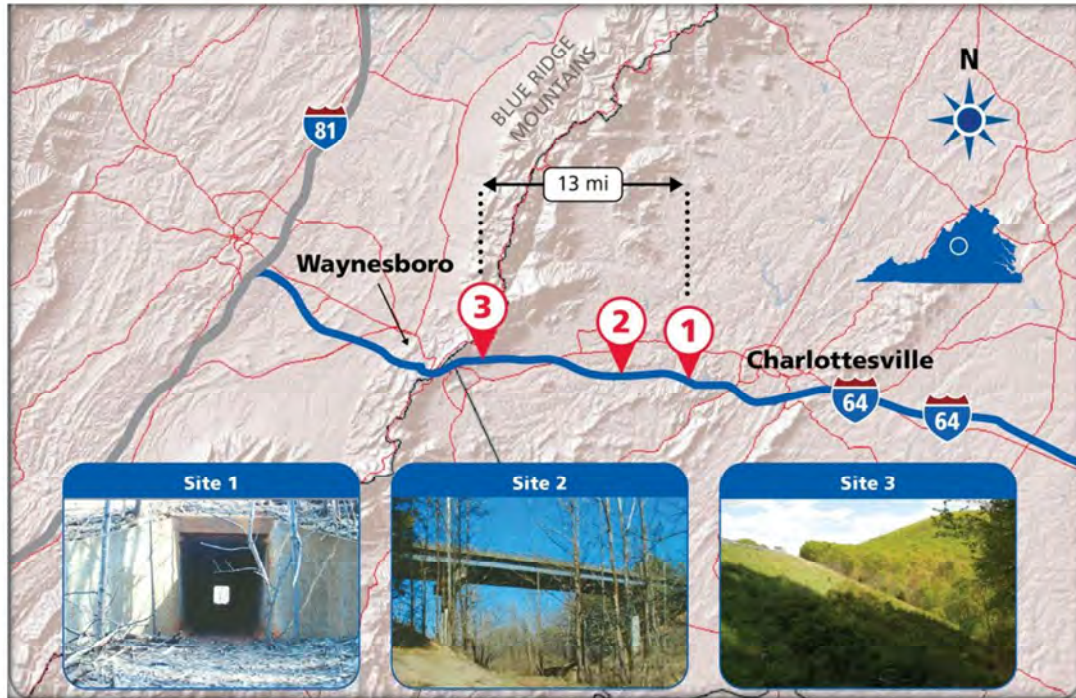
Figure 3. Study Sites Within the 23-Mile Project Area. Sites 1 and 2 are underpasses used by deer, and Site 3 is a stream corridor / highway intersection.

These underpasses and their adjoining sections of highway were chosen as sites for further evaluation (Sites 1 and 2, Figure 3). The 5-mile separation between the sites is too large to accommodate wildlife passage at both structures by the same individuals but is small enough that the surrounding habitat is similar in terms of topography and vegetation. Because the

For these reasons, Donaldson hypothesized that a driver warning system might be an effective DVC mitigation option at stream corridor / highway intersections (Donaldson, 2012a, 2012b). However, additional information was needed regarding deer and black bear activity in these drainage areas. A stream corridor / highway intersection along Afton Mountain was selected for further evaluation (Site 3, Figure 3).

Study sites included a large bridge underpass and a box culvert that were known to be used by deer and a stream corridor / highway intersection (Figure 3). Because the underpasses differed greatly in size and wildlife use, they allowed a useful comparison with regard to adjacent roadside deer activity and DVCs. Sites were monitored with trail cameras for 2 years. Two years of carcass removal data provided a context for the evaluations.

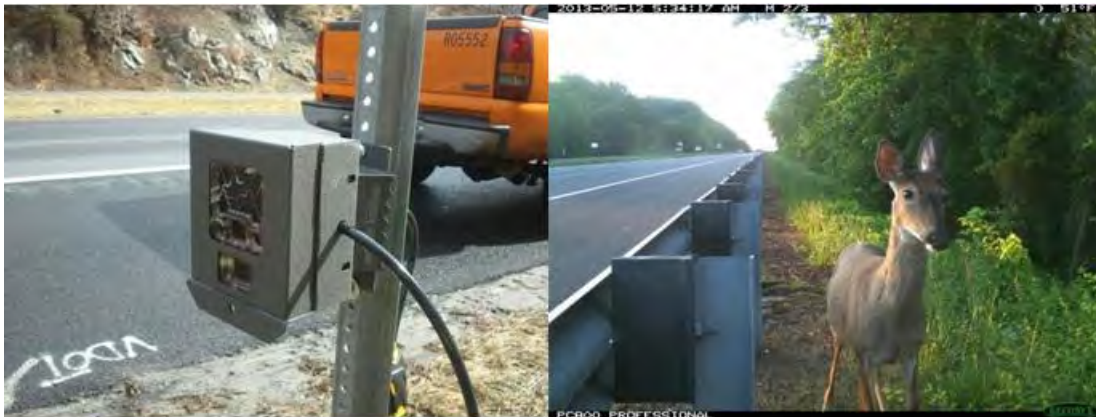
Figure 4. Camera Placement Along Highway (*left*); Angle of View (*right*)

As detailed later, cameras were installed at underpasses and along the interstate roadside. Cameras along the roadside were positioned within 2 feet of the paved shoulder and mounted on poles that were inserted in the ground or attached to a guardrail. Cameras were angled such that the area of detection included the entire width of the shoulder to the area approximately 30 feet off the shoulder at the extent of the camera range (Figure 4). Cameras at underpasses were mounted on trees at the entrances of the box culvert and beneath the bridge underpass. Researchers visited the cameras once every 2 months to replace the Secure Digital (SD) cards that stored the images. Batteries were replaced as needed.

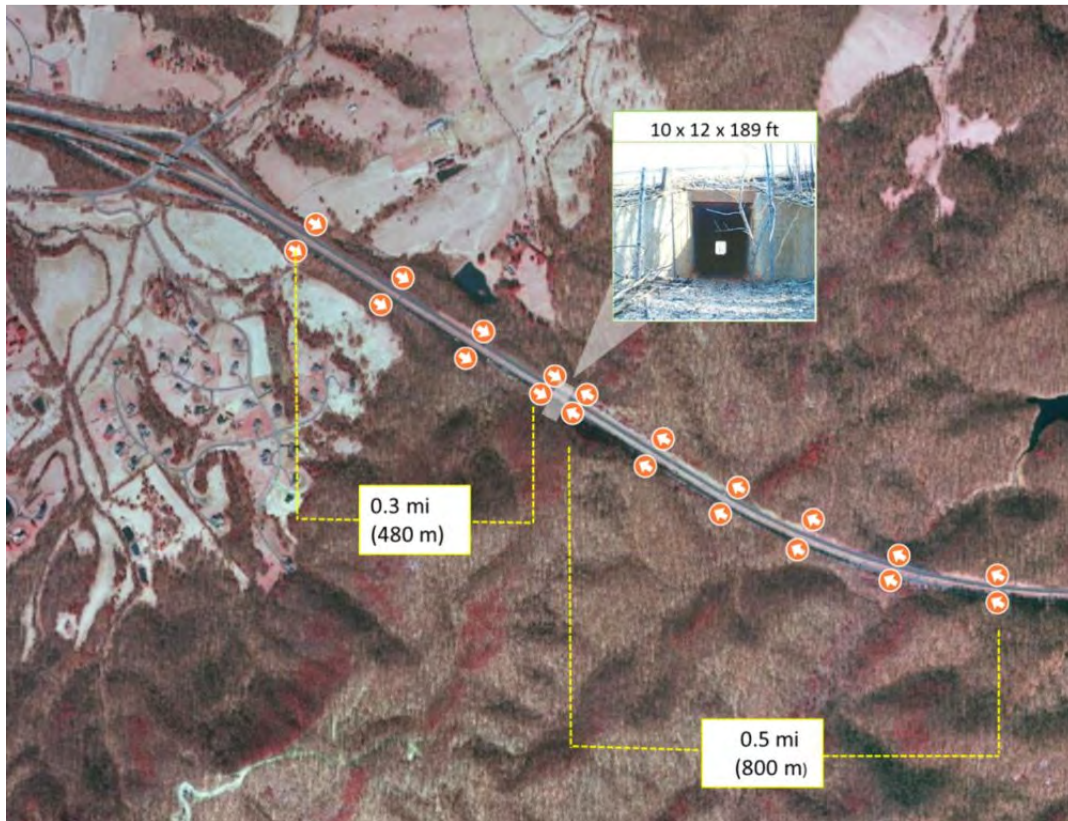
Figure 5. Camera Placement Along Roadside at Site 1. Cameras (represented by circles with arrows indicating the direction the camera faces) are centered above the underpasses and extend up to 0.3 mile to the west and 0.5 mile to the east.

At Site 1, 20 cameras were divided between the eastbound and westbound lanes (Figure 5). One camera was also placed at each of the two entrances to the box culvert. Cameras were placed along the shoulder of the highway directly above the underpass entrances to capture the deer that did not use the underpass and traveled directly up to the highway. Cameras were evenly spaced in 0.1-mile intervals in the east and west directions from the cameras centered above the underpass. Camera placement extended 0.5 mile on the east side of the underpass and 0.3 mile on the west side, for a combined length of 0.8 mile. Immediately beyond 0.3 mile west of the underpass, the ground drops off the paved shoulder next to the eastbound and westbound lanes, creating a steep slope that likely precludes deer movement (and negates the need for cameras).

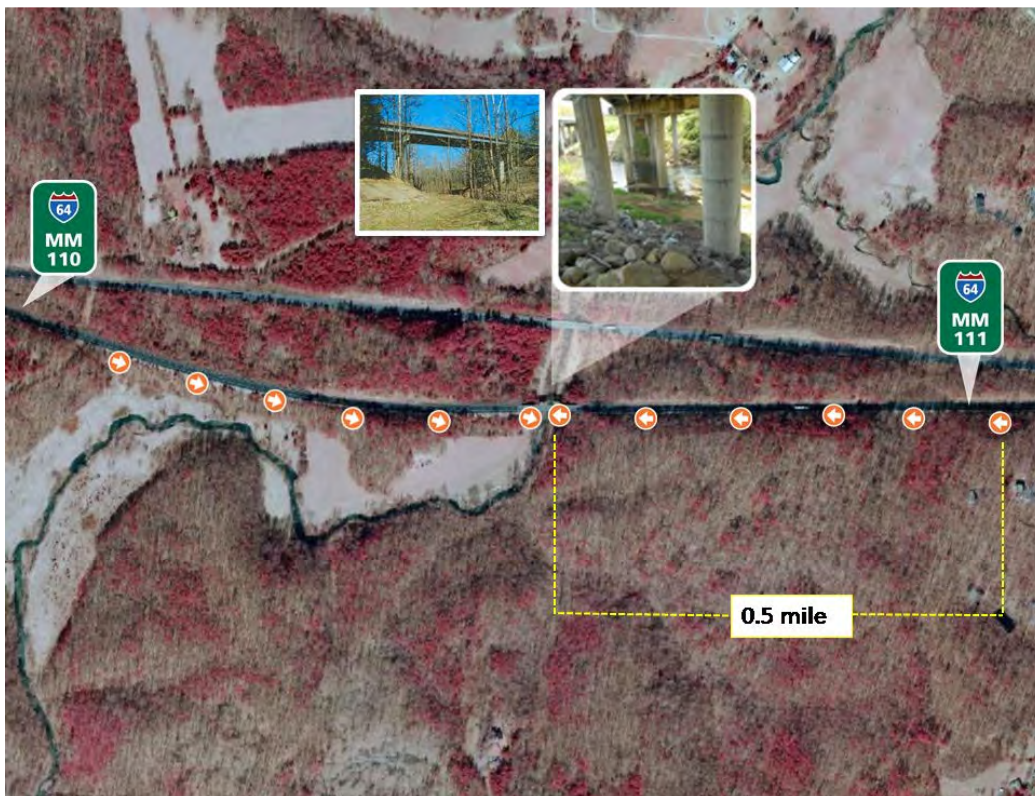
Figure 6. Camera Placement Along Roadside at Site 2. Cameras (represented by circles with arrows indicating the direction the camera faces) are centered above the underpasses and extend 0.5 mile to the east and west.

The underpass at Site 2 is a bridge along the eastbound lane of I-64, 5 miles west of Site 1. A wide median separates the eastbound and westbound lanes. The bridge is 307 feet long (or wide, from the perspective of an animal crossing beneath it) and was constructed in 1969 to span the Mechum River. The river width is approximately 45 feet, with approximately 10-foot-wide grassy strips on each side to allow the passage of farm vehicles. The remaining area beneath the bridge is sloped with sandy substrate, which is also heavily traversed by wildlife (Donaldson, 2007). The surrounding habitat comprises a mixture of trees and open farmland. Sixteen cameras were placed along a 1-mile segment of the eastbound lanes at Site 2, with the bridge underpass at the center (Figure 6).

Given the number of available cameras, placing them along only the eastbound lanes allowed for more coverage of the highway corridor at Site 1 (where cameras were placed in pairs along the eastbound/westbound lanes across the highway). In addition, because of the wide median between lanes, placing cameras in pairs across the eastbound and westbound lanes would have made inferences about deer and bear crossing the full highway problematic. For the analyses and reported results for Sites 1 and 2, data from each eastbound and westbound camera pair at Site 1 were averaged. This allowed for comparisons of roadside deer activity between Sites 1 and 2. Cameras along the highway were positioned immediately above and on either side of the bridge and spaced at 0.1-mile intervals in the east and west directions along the highway. Four cameras were placed beneath the bridge underpass (two cameras were positioned on both sides of the river) in order to capture the entire area of dry land beneath the bridge.

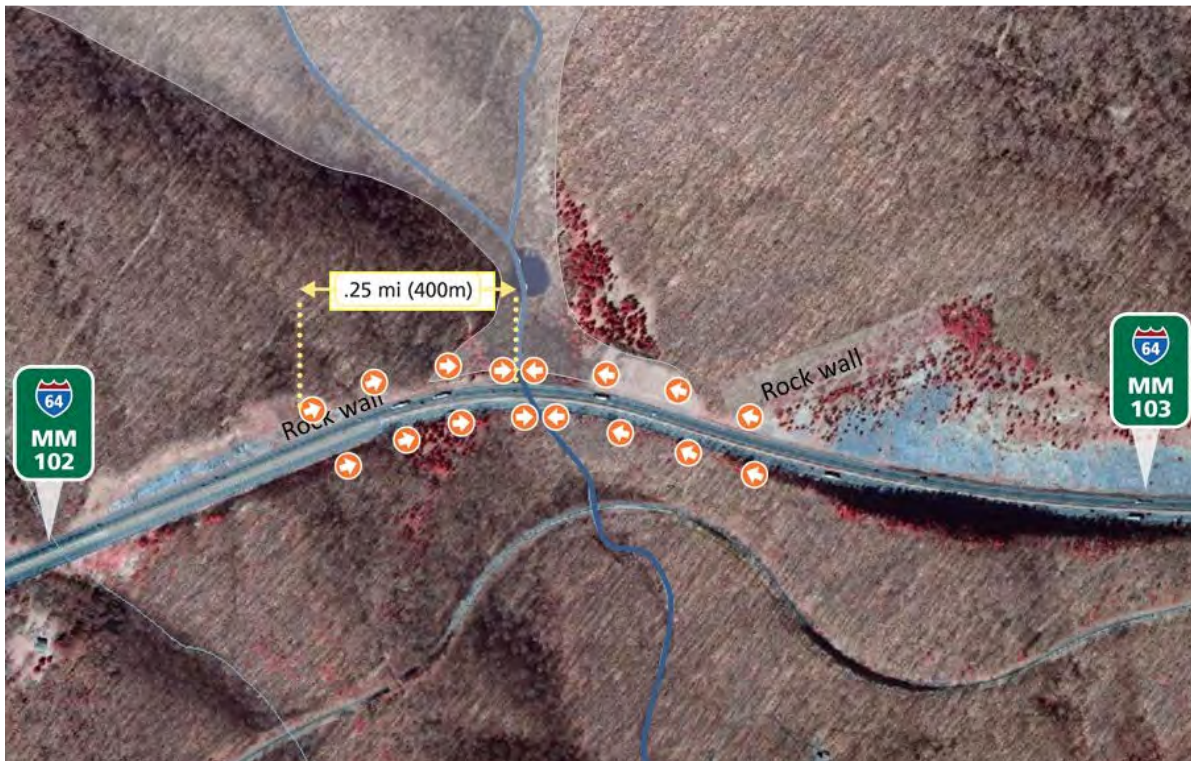
Figure 7. Camera Placement Along Roadside at Site 3. The shaded area highlights the contours of the landscape; the steep topography creates a saddle that may help funnel wildlife toward this section of the interstate. Cameras (represented by circles with arrows indicating the direction the camera faces) are centered on the stream corridor and extend along the highway 0.25 mile to the east and west.

The primary consideration in determining camera placement at Site 3 was the surrounding landscape features that might influence deer and black bear movement (see Figure 7).

The steeply sloped topography on the north side of the interstate appears to create a saddle that potentially serves as a funnel for wildlife movement. The funnel narrows, or forms a “bottleneck,” just north of the corridor intersection with the northern (westbound) lanes of the interstate, which may result in an area of concentrated wildlife activity.

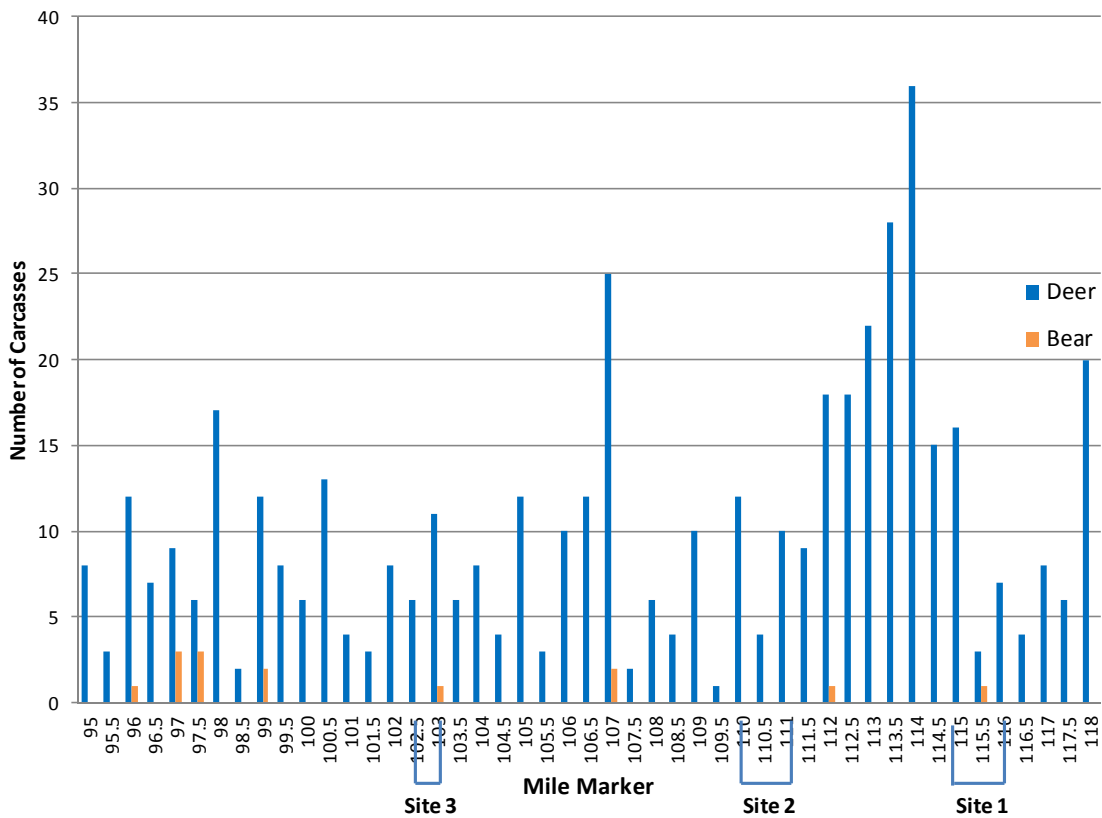
Figure 8. Cumulative Deer and Bear Carcass Removals From MM 95 to MM 118 Over 3-Year Period (April 2012–March 2015). Grouped in 0.5-mile intervals.

There were 474 DVCs and 14 bear-vehicle collisions documented between MM 95 and MM 118 over 3 years, an average of 158 deer and 5 bear per year. This is an average of nearly 7 DVCs per mile per year. Figure 8 illustrates the location of these collisions relative to the study sites. Nine of the 14 bear deaths occurred between MM 96 and MM 99 on Afton Mountain. The 0.5-mile section with the most DVCs was situated between Sites 1 and 2, with 54 DVCs during the 3-year data collection period (an average of 18 DVCs per year in this 0.5-mile section).

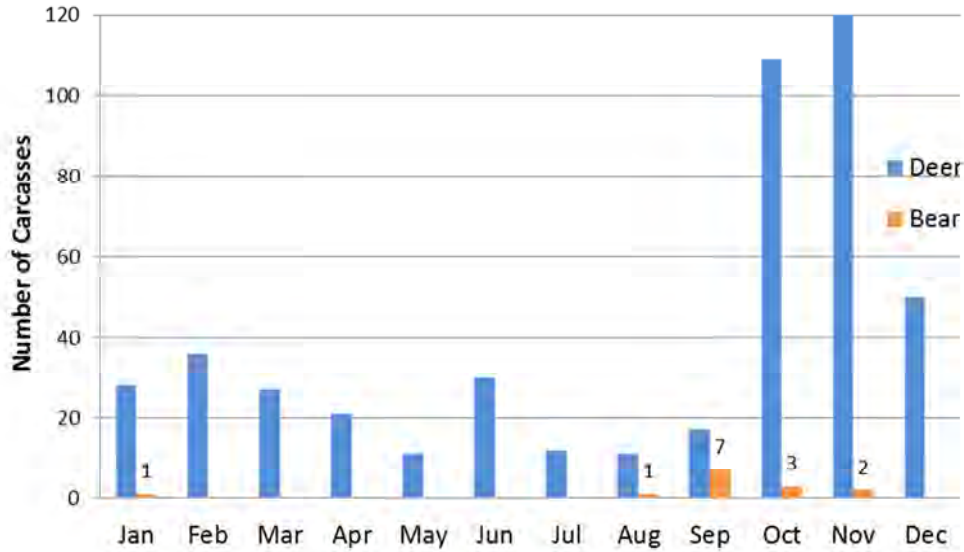
Figure 9. Monthly Vehicle Collisions With Deer and Bear Over 3-Year Period (April 2012–March 2015)

Figure 9 illustrates the monthly number of vehicle collisions with deer and black bear over the 3-year data collection period.

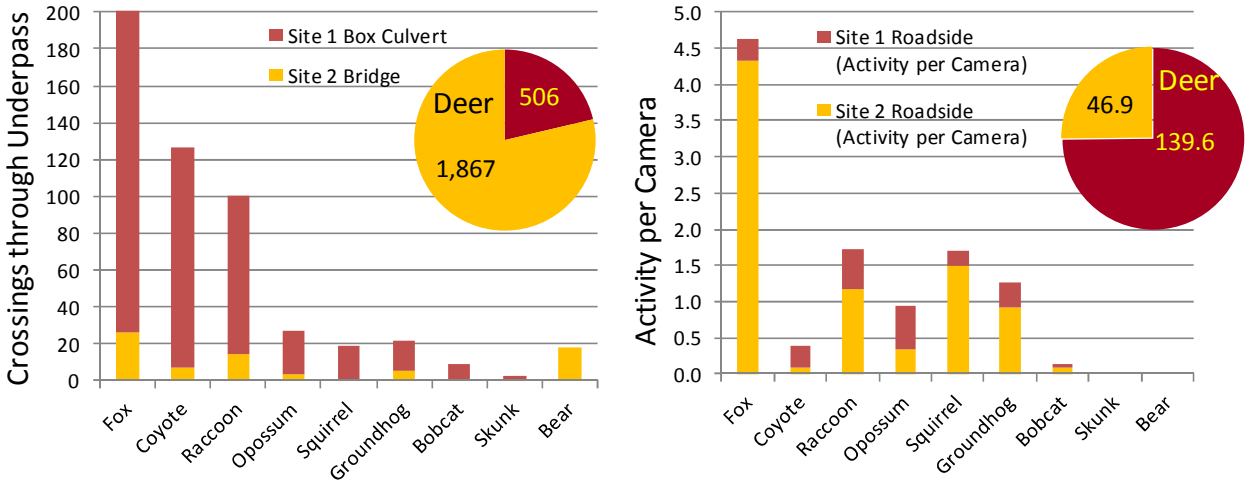
Figure 11. Comparisons of Wildlife Activity at Sites 1 and 2. Wildlife crossings through underpasses (left) and activity per camera along roadside (right) over the 2-year monitoring period.

Wildlife Activity. Figure 11 illustrates a comparison of the detected wildlife crossings through the Site 1 and 2 underpasses and the activity per camera along adjacent roadside sections. Other than deer and bear, cameras captured 674 individuals of mammalian species at the study sites. A greater number of small to medium-sized wildlife crossed through the Site 1 box culvert than passed beneath the Site 2 bridge. This corresponded with the lower activity of these species along the roadside at Site 1 than at the roadside at Site 2 (Figure 11). Deer activity at both sites was substantially higher than that of other wildlife.

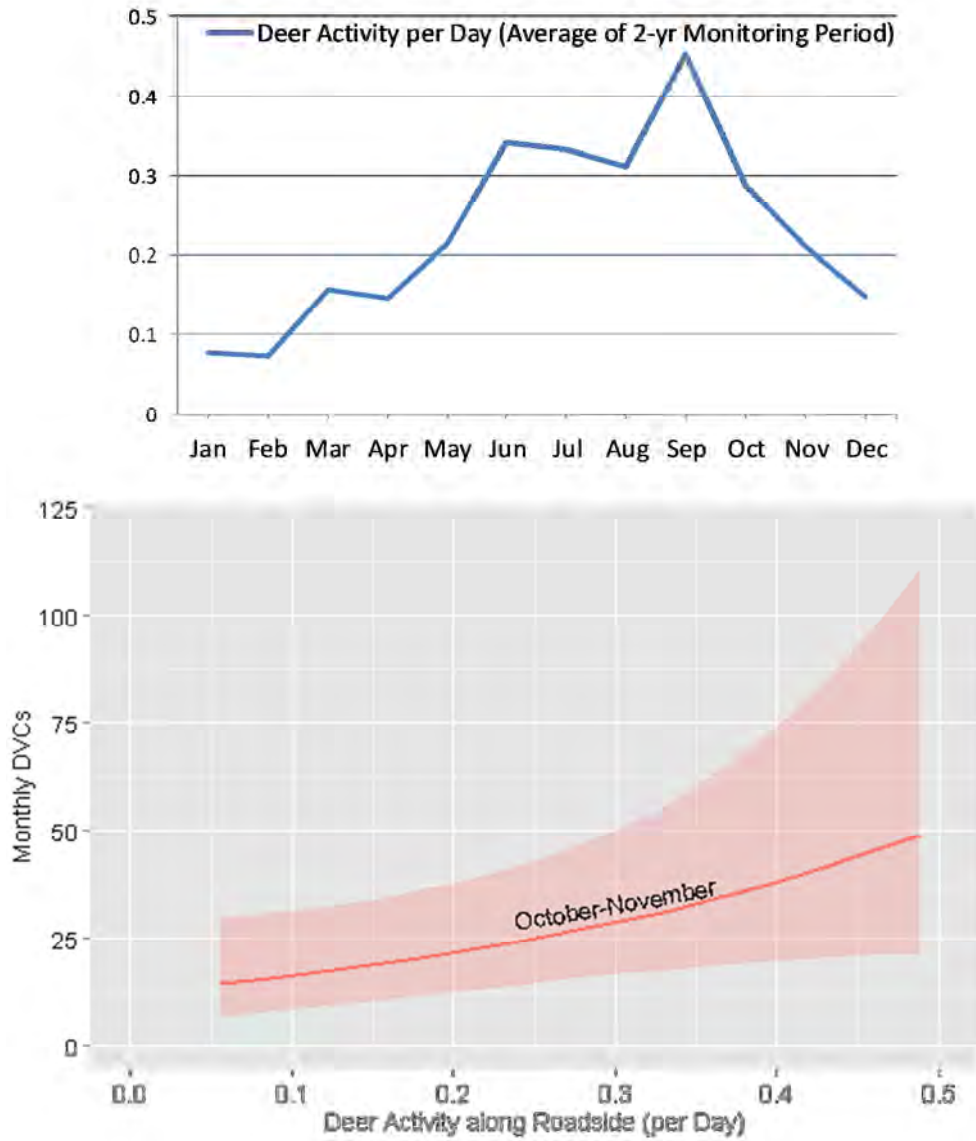
Figure 12. Daily Roadside Deer Activity per Month at Combined Sites 1 and 2 (*top*) and Relationship Between Deer Activity and DVCs (*bottom*). The bottom figure illustrates the positive correlation between monthly DVCs in the 11-mile study area and roadside deer activity at the study sites, which was strongest in October and November. In the bottom figure, the solid line represents a mean prediction curve and the band surrounding the curve represents a 95% confidence prediction limit.

Deer Activity and Behavior. Deer activity along the roadside at Sites 1 and 2 peaked in September (Figure 12). This suggests that deer may use roadsides as foraging habitat during the late summer when herbaceous vegetation is still succulent and before acorns have fallen in the more heavily forested areas adjacent to the road (N. Lafon, personal communication).

A statistically significant relationship was found between monthly roadside deer activity at the study sites and DVCs in the 11-mile project area (i.e., as roadside deer activity increased, DVCs increased) (Figure 12). Figure 12, *bottom*, which was created based on predictions from the final negative binomial regression, illustrates this positive correlation, which was strongest in October and November, and illustrates that (for example) with a deer activity of 0.3 deer per day (or approximately 10 per month) along the evaluated study sites (which have a combined roadside length of 1.8 miles), approximately 28 DVCs per month were predicted within the 11-mile study area.

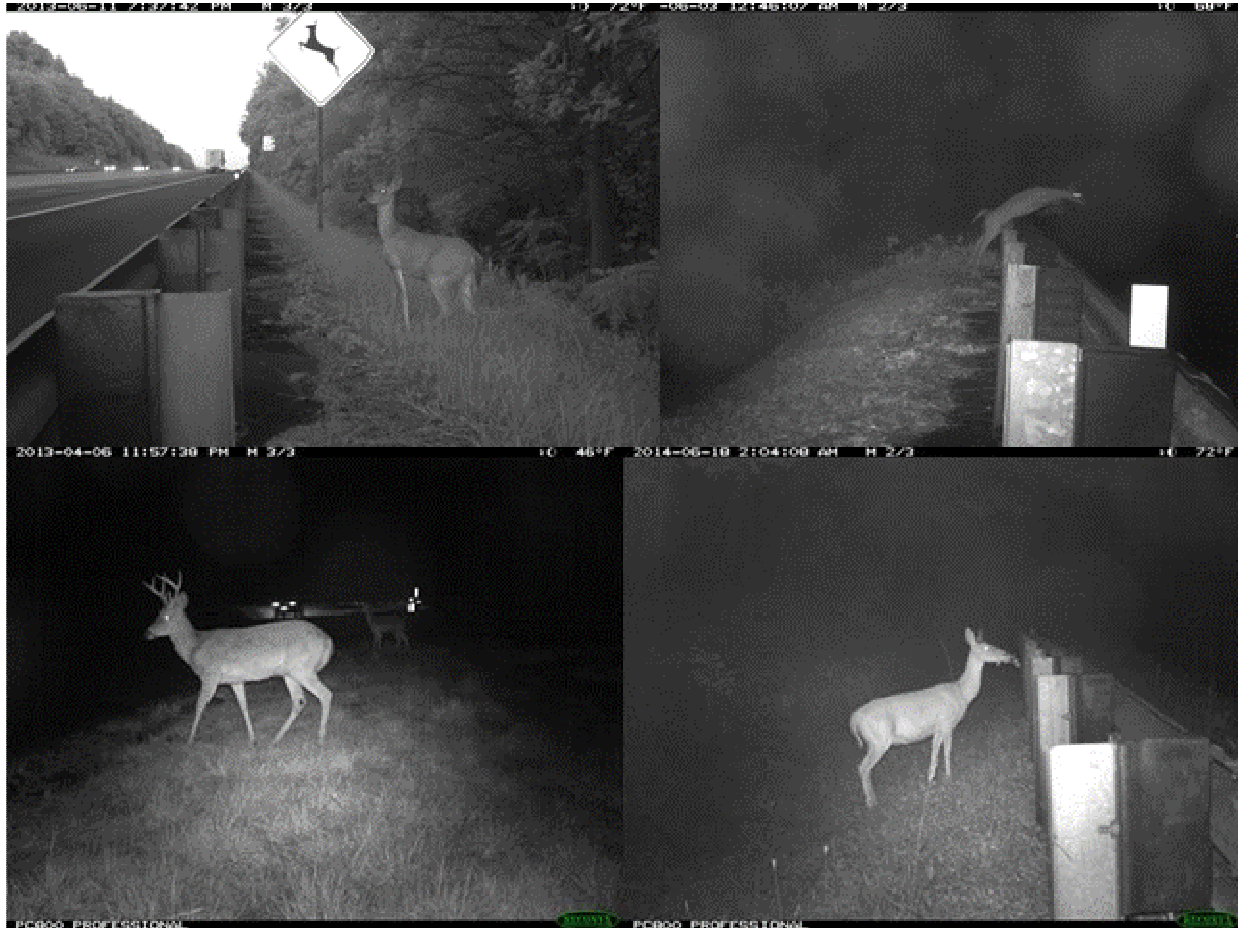
Figure 13. Behavior Considered Responsive to Interstate (left top and bottom), Crossing Attempt (top right), and Unresponsive Feeding Behavior (bottom right)

There were no significant differences between Sites 1 and 2 with regard to the evaluated behaviors ($p > 0.05$). Given the similarities between Sites 1 and 2 with regard to deer behavior (Table 2), roadway factors (sight distance, vehicle speed, etc.) may play a role in the high number of DVCs at Site 2 relative to deer activity. Figure 13 illustrates some of the behaviors listed in Table 2.

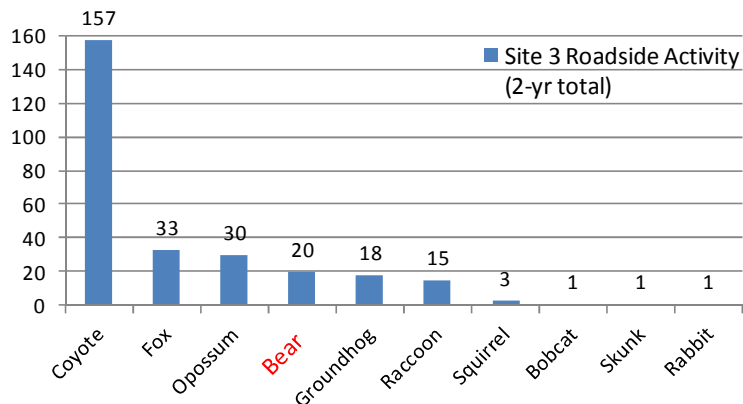
Figure 14. Wildlife Activity at Site 3 Over the 2-Year Monitoring Period

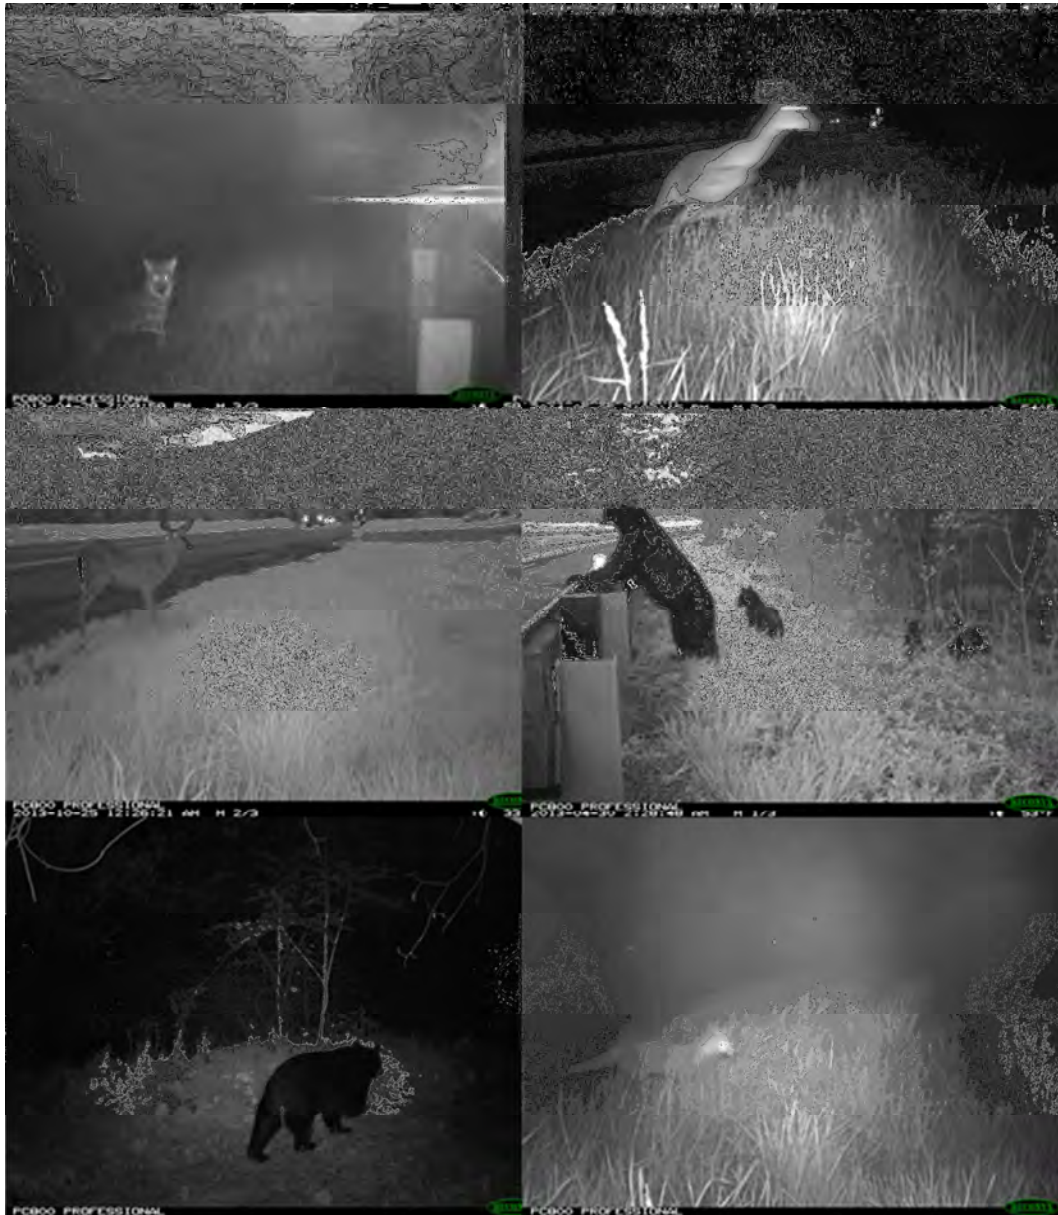
Figure 15. Photographs of Deer, Black Bear, a Coyote (*top left*), and a Fox (*bottom right*) Along Roadside at Site 3

Wildlife activity totaled 3,370 for deer and 275 for non-deer species along the Site 3 roadside over the 2-year monitoring period (Figures 14 and 15). Bears visited the roadside 20 times. Other than deer, coyotes were the most common species photographed along the roadside.

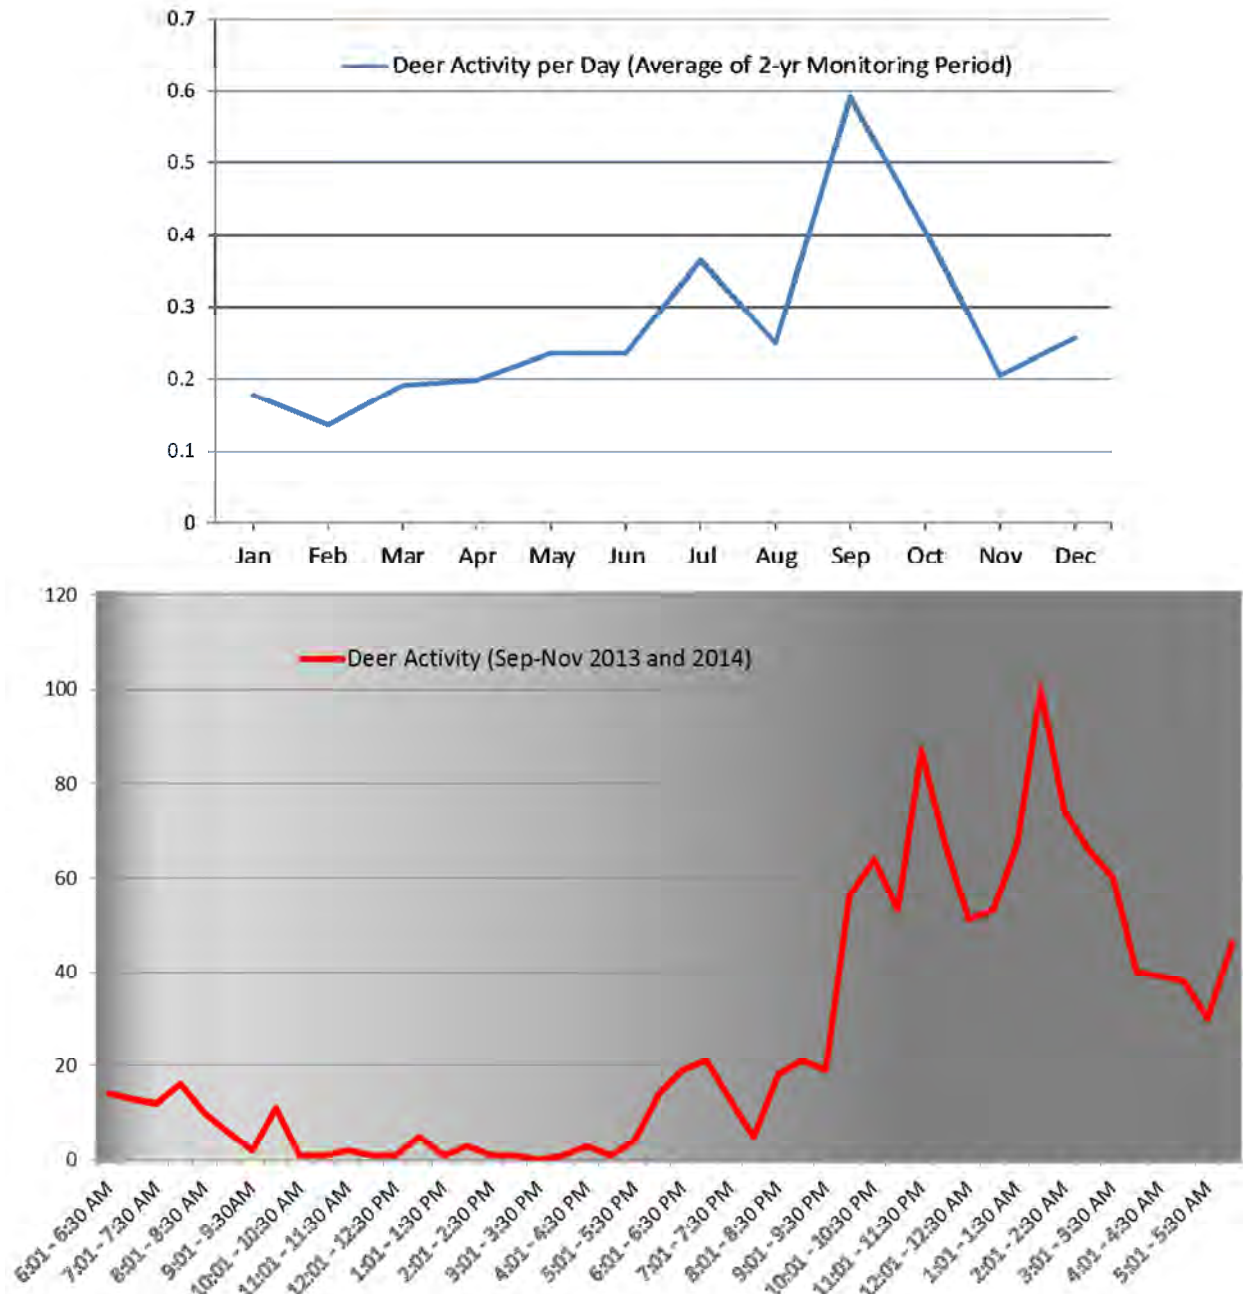
Figure 16. Daily Roadside Deer Activity per Month (*top*) and Deer Activity by Time of Day: September-November (*bottom*). Lighter shades correspond with daylight hours during fall months in Virginia.

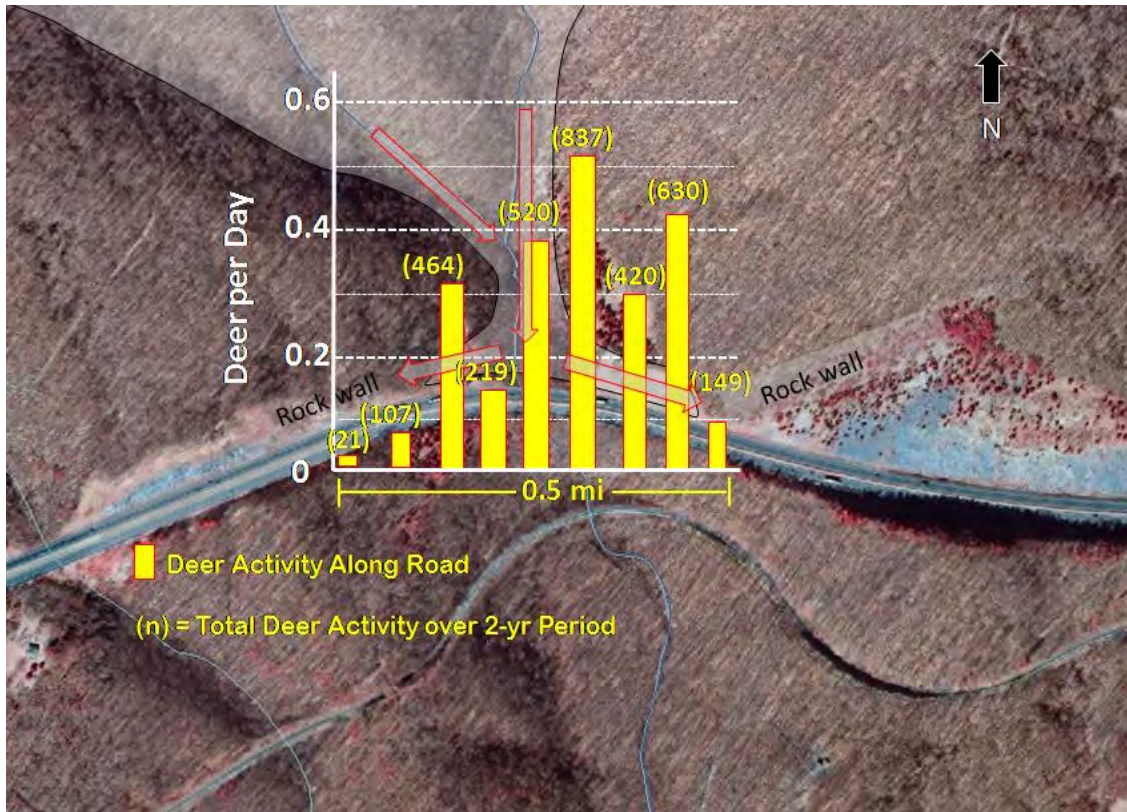
Figure 17. Deer Activity Along Interstate at Site 3. Bars are positioned at camera locations and illustrate activity from corresponding north and south cameras. The shaded area highlights the contours of the landscape and the saddle shape created by the steep topography. The arrows represent likely deer movement along the stream corridor toward and along the roadside (as indicated by camera data).

Figure 17 illustrates deer activity at the camera locations. Ninety percent of the deer roadside activity illustrated in Figure 17 occurred on the northern side, or westbound lanes, of the highway, where the drainage was saddled by steep slopes. Deer roadside activity was statistically correlated with the distance from the stream corridor (according to the final negative binomial regression) (Figure 18). Specifically, deer activity was highest at the stream corridor / highway intersection and decreased farther away from this intersection where the roadside topography was impassable. These findings show that deer movement was influenced by the stream corridor and the associated steep topography to the north of the highway. The landscape in this area serves as a funnel that concentrates deer in a relatively short section of highway.

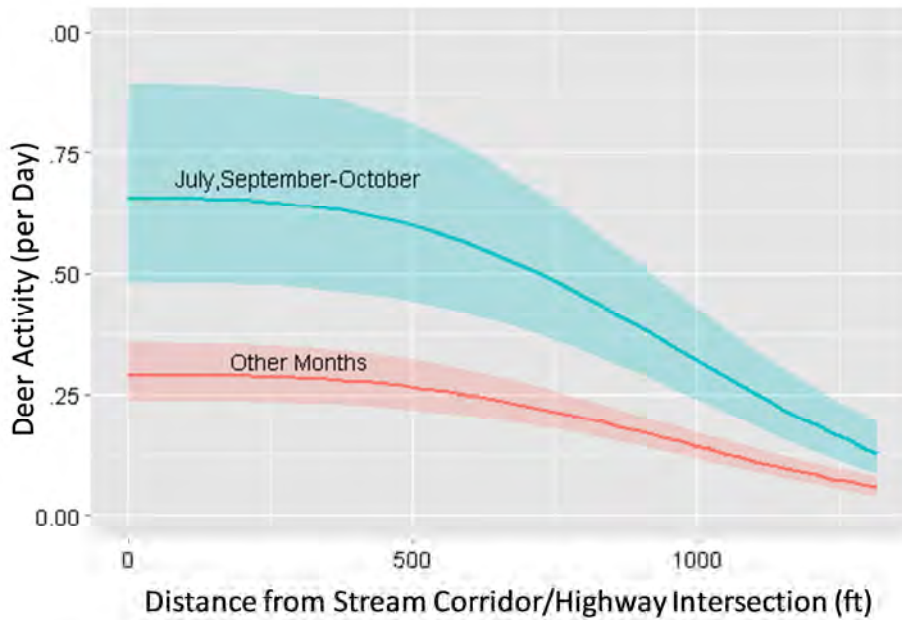
Figure 18. Graph Illustrating Statistically Significant Decrease in Daily Deer Activity As Distance From Stream Corridor / Highway Intersection Increases. The solid line represents a mean prediction curve, and the band surrounding the curve represents a 95% confidence prediction limit in the bottom graph. The months with the highest deer activity (July, September-October) are separated from the other months to highlight the stronger statistical relationship during those months.

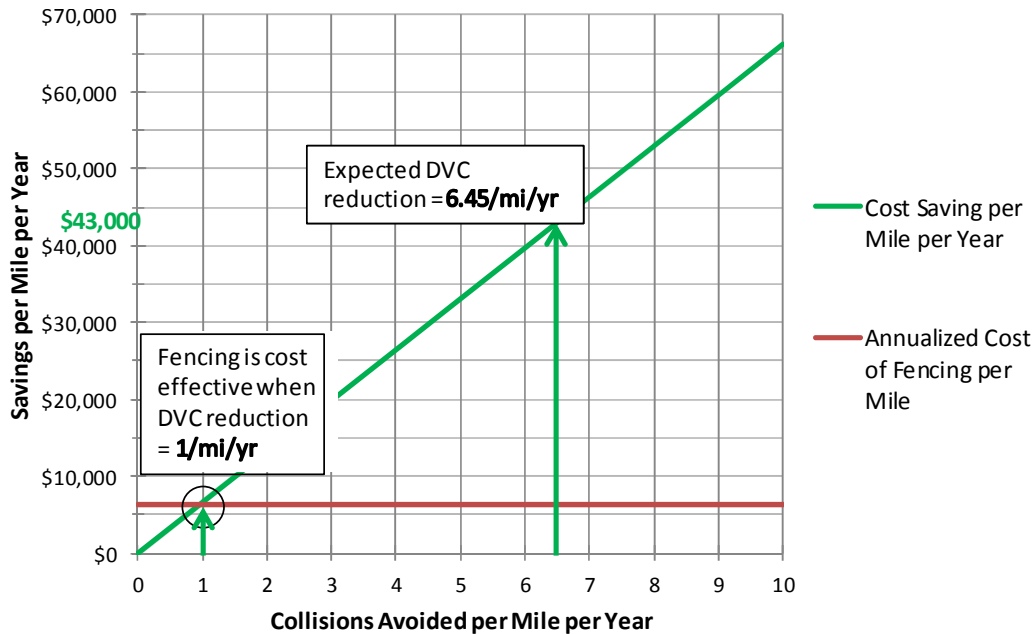
Figure 19. Cost Savings From Reduction in DVCs As Result of Installation of Fencing and Escape Structures

The cost/benefit analysis resulted in the following findings for one underpass site at which fencing and jump-outs are installed (as illustrated in Figure 19):

- The annualized costs of fencing and jump-outs are \$6,328 (based on a total cost of \$100,052).
- Fencing with jump-outs is cost-effective in terms of savings from DVC reduction when it prevents a minimum of 1 DVC per mile per year.
- With an expected 86% reduction in DVCs after fencing installation (Huijser et al., 2009), 6.45 DVCs would be avoided per mile per year. This results in a savings of approximately \$43,000 per mile per year.
- Over the 25-year service life of the fencing, the total savings would be \$501,473.
