Effects of training and display content on Level 2 driving automation interface usability

June 2019

Alexandra S. Mueller Jessica B. Cicchino Insurance Institute for Highway Safety

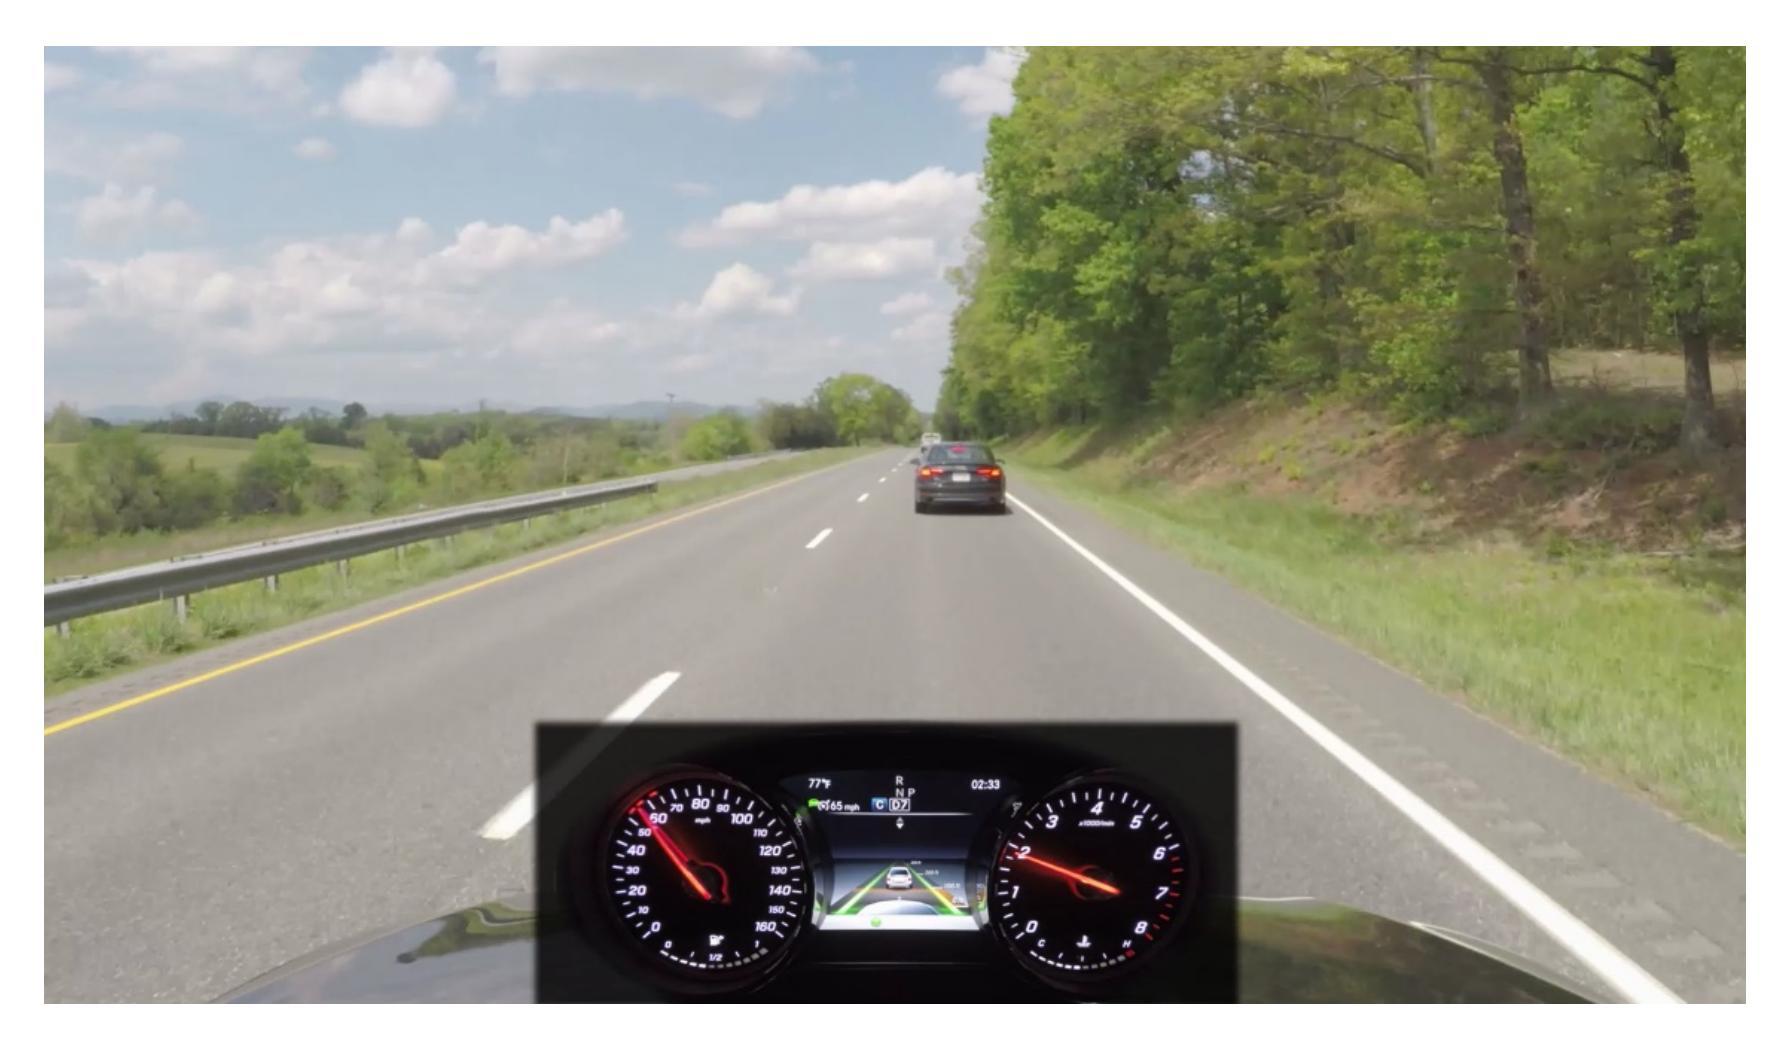
2.2.1 Video stimuli. Videos displayed two points of view taken from the driver's perspective showing the instrument cluster and the forward roadway (see Figure 1). The two video feeds were synchronized, with the instrument cluster video overlaid at the bottom of the forward roadway video, to show system-related changes in the instrument cluster corresponding with events on the road. Videos of the instrument cluster and forward roadway were collected simultaneously on public roadways in Virginia. ACC and lane centering were turned on for the duration of every video, with speed and following distance set prior to each video's start. The same driving scenarios were captured for the simple and complex instrument cluster groups, and special care was taken to ensure that the videos were equivalent for a given scenario.

Figure 1. Still frame from one of the experimental videos.

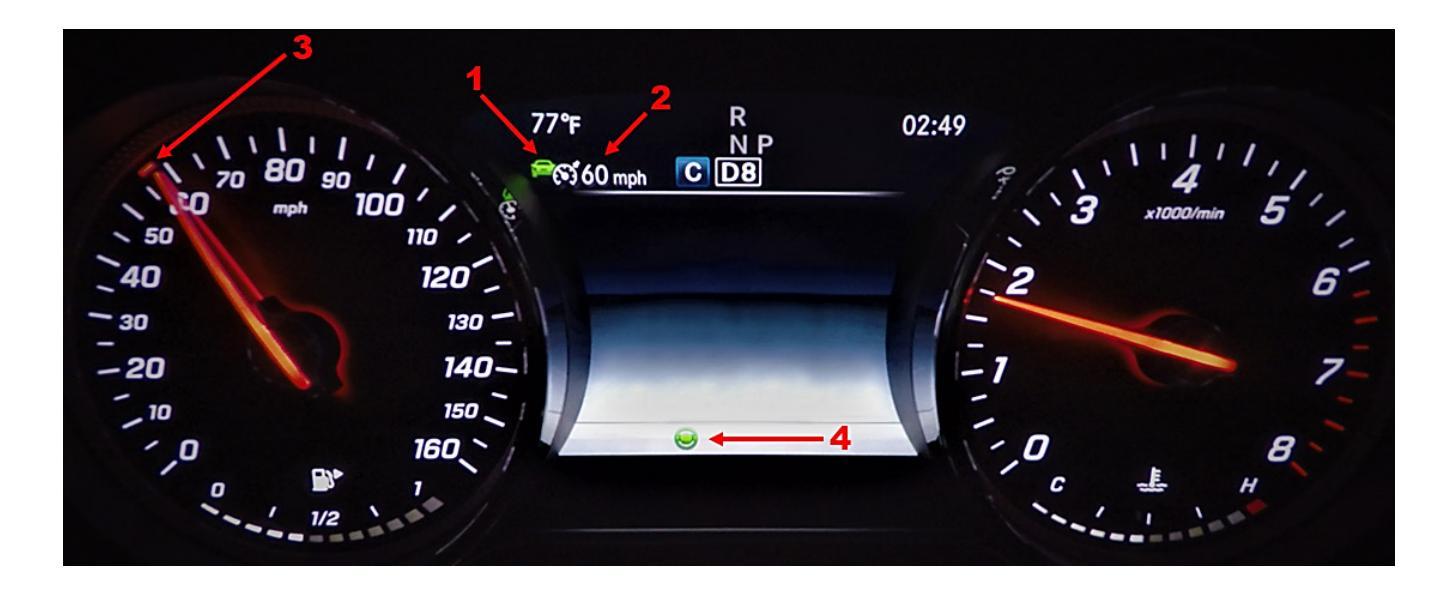
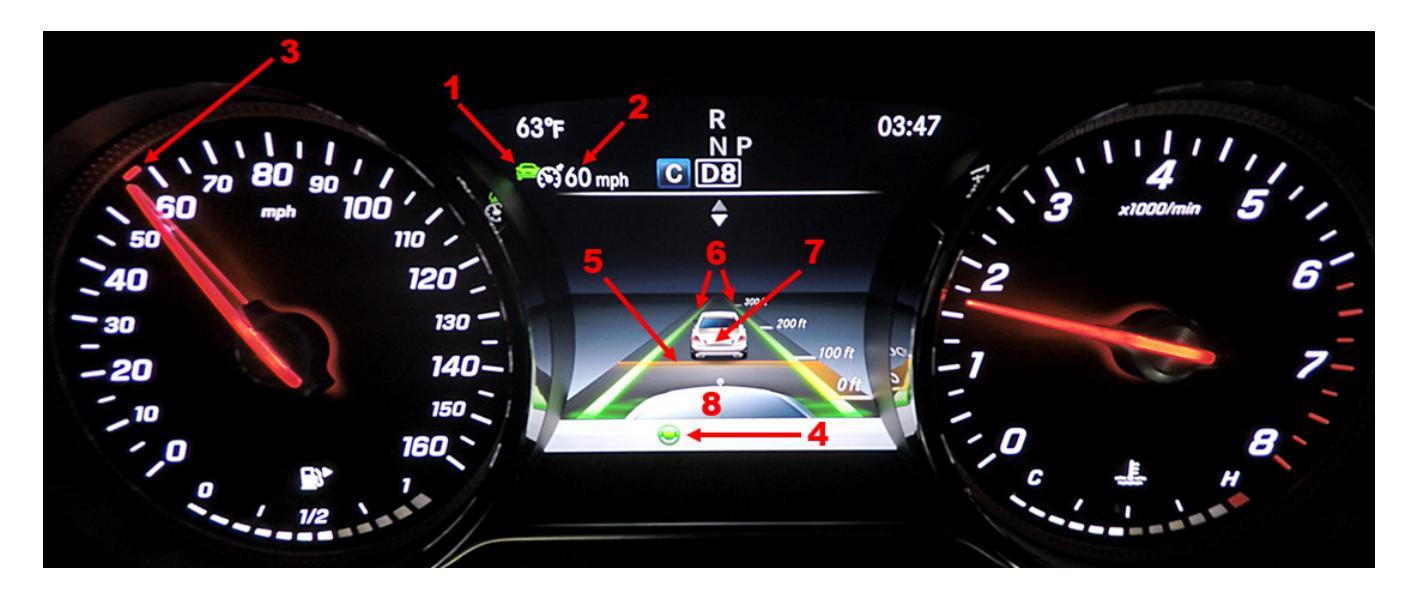
Figure 2 shows the simple and complex instrument cluster displays with the icons relevant to the Level 2 features highlighted with arrows and numbers for description purposes here, but the numbers and arrows were absent in the experimental videos. The displays updated in real time when conditions changed. In both displays, the vehicle icon marked with #1 turned green when a lead vehicle was detected and grey when no lead vehicle was detected. The speed to which ACC was set was displayed through #2. The red highlighted flag against the speedometer gauge is marked with #3 and displays the vehicle's current speed relative to the set speed. If a lead vehicle was present and driving slower than the set speed, that red flag against the speedometer would extend down to ACC's adjusted speed, thereby displaying the speed differential of the lead vehicle relative to the participant's vehicle set speed. Lane centering activity was represented through the steering wheel icon denoted by #4. The steering wheel icon would turn green when the lane centering system was actively controlling steering, sometimes flash yellow briefly when transitioning from active to inactive, and turn grey when it was temporarily inactive due to road conditions.

Figure 2. Instrument cluster layout in the simple (top) and complex (bottom) conditions.

The complex instrument cluster contained additional information. The following distance to which ACC was set was denoted by an orange line (#5) and remained on screen regardless of whether a lead vehicle was present. Lane line detection was shown through #6, with the lane lines highlighted in green when the vehicle detected them and grey when it did not detect them. Because the lane centering system could be active without detecting lane lines (i.e., by following a lead vehicle) and lane lines could be detected when the system was temporarily inactive, this display was not a completely reliable indicator of lane centering operating status. Similar to icon #1, a lead vehicle was also represented through #7 when it was detected by ACC, and #8 represented the participant's vehicle, which was displayed at all times.

Participants in the two trained groups were given an orientation to the interface using one of the two images of the instrument cluster in Figure 2. During the orientation, the research assistant described the icons used by ACC and lane centering, their potential states (e.g., color changes), and their meanings, as described in the 2.2.1 Video Stimuli section. The information provided during the orientation was from the owner manual. Participants in the untrained groups were allowed to view the image of the instrument cluster belonging to their condition to orient themselves to the information and icons present, but the research assistant did not provide any information about what information was relevant to ACC or lane centering, nor did the research assistant explain what any of the information or icons meant. The experimental session was conducted using a desktop computer to present the videos and collect the questionnaire responses. The research assistant played a video, the order of which was randomized, after which the participant completed the associated questionnaire. Participants were not allowed to rewatch any of the videos. Once all the videos were shown and the corresponding questionnaires were completed, participants were allowed to take a short break. Finally, they completed questionnaires on information sources in the instrument cluster used to monitor ACC and lane centering activity, usability, and demographics.

Different sources of information were available to choose from between the instrument cluster content conditions, as shown in Figure 2. To determine whether the ACC system had detected a vehicle ahead, participants in the simple display group had only one reliable source to use, the green car icon in the upper left of the instrument cluster (#1), whereas those in the complex display group had two reliable sources available: the green car icon (#1) and the lead vehicle in the center of the display (#7) (see Table 4). There was a significant effect of training, F(1, 76) = 5.68, p = 0.02, in that more trained participants

The lane lines in the center of the instrument cluster (#6 in Figure 2), which were present only in the complex display, were an unreliable source of information to use when determining whether the lane centering system was actively steering because the vehicle could detect lane lines while the lane centering system was temporarily inactive and vice versa. Nevertheless, this was a commonly used source of information for participants who viewed the complex display, regardless of training.

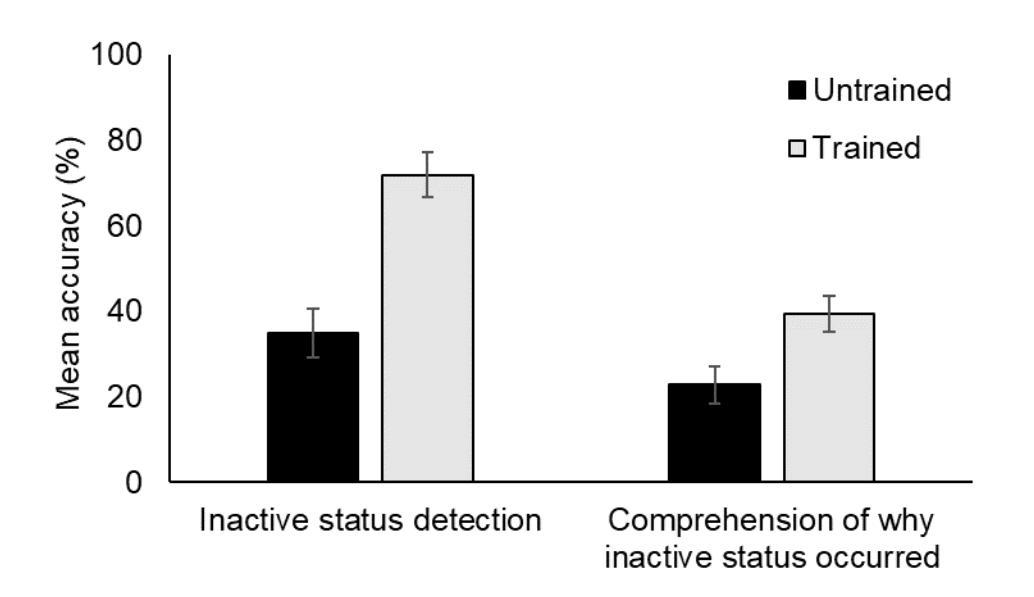
Although training had no significant influence on status detection or functional limitation comprehension for ACC, it did influence how well participants recognized status changes for the lane centering system when it temporarily deactivated and understood why deactivations occurred. As shown in Figure 3, participants who received an orientation prior to the experiment were more than twice as accurate at detecting when the lane centering system had stopped working than those who were untrained. Similarly, training increased comprehension of why system deactivations occurred. Performance was unaffected by instrument cluster content or the interaction between instrument cluster content and training.

Figure 3. Effect of training on mean (%) accuracy of lane centering inactive status detection and functional limitation comprehension. Error bars are \pm SE.
