RR 19-20 | October 2019

## SYSTEM-WIDE IMPLEMENTATION OF RAIL RIGHT-OF-WAY INCURSION TREATMENTS

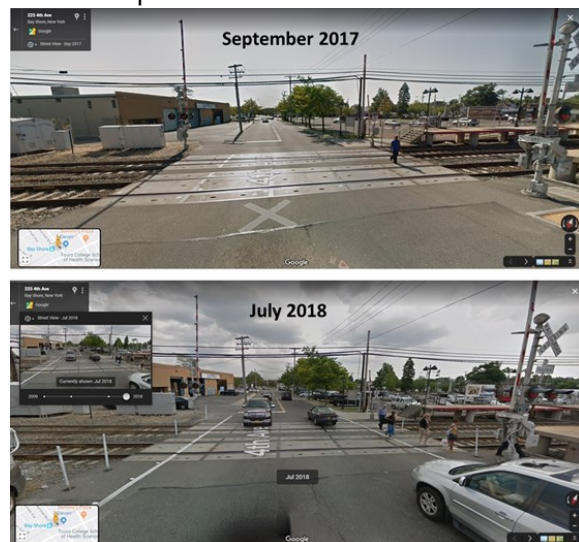
**Figure 1. ROW Incursion Treatments Installed at the LIRR Crossing on 4th Ave in Bay Shore, NY (Crossing ID 338023U)**

From 2016 through 2018, the Volpe Center partnered with SunRail to develop, install, and evaluate promising vehicle ROW incursion prevention engineering treatments [1]. Following this demonstration project, in early 2018 the Metropolitan Transportation Authority (MTA) Long Island Rail Road (LIRR) announced the *LIRR Forward* plan [2], which included the implementation of system-wide, high-visibility safety delineators and striping. A Google Maps before-and-after snapshot of one of these crossings is shown in [Figure 1](#) (<https://goo.gl/maps/SMdddn9PDgTFwq8R6>). The top picture shows pre-installation conditions as of September 2017, and the bottom picture shows post-installation conditions as of July 2018. Note the addition of the white edge pavement markings and reflective markers through the crossing, and flexible delineators on both sides and in-between the tracks.

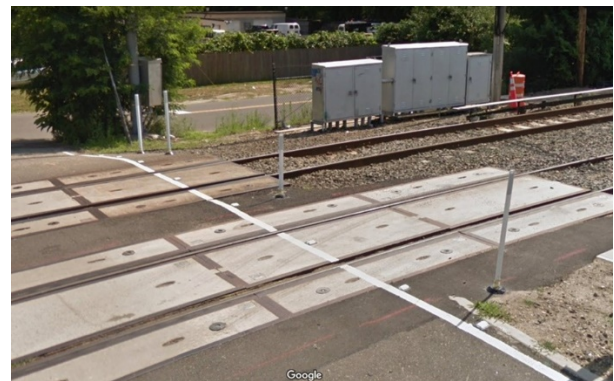
**Figure 2. ROW Incursion Treatments Installed at the LIRR Crossing on Pond Road in Ronkonkoma, NY (Crossing ID 338175R)**

LIRR completed the installation of the white pavement markings, reflective markers, and delineators at all of their 296 grade crossings in the summer of 2018. An example of this treatment as installed at Pond Road in Ronkonkoma, NY (Crossing ID 338175R) is shown in [Figure 2](#).
